Project Name: Winterburn Bridge

Client: North Yorkshire County Council

Date: October 2018 – Nov 2018

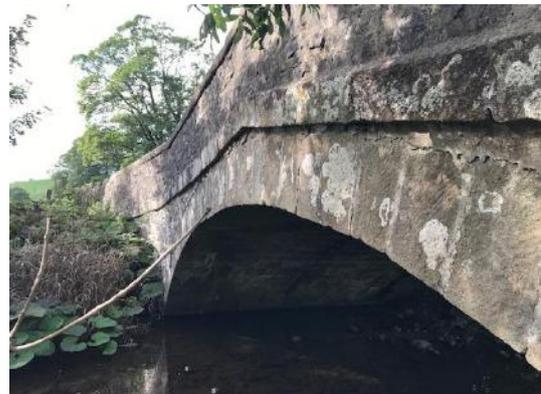
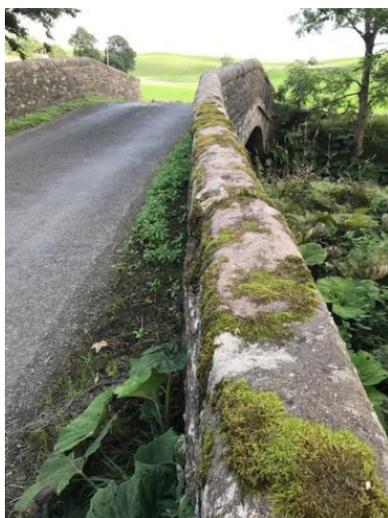
Winterburn Bridge was in a poor state of repair, the stone arch had started to spread causing several key stones to dislodge and drop down severely impeding the structure ability to support traffic flows above. The problem was

made worse by the steep camber over the bridge causing vehicles to “bottom put” applying an impact load to the structure. In addition to this the parapet had been damaged and was bowing outwards and had been struck several times by passing vehicles.

To address the problem several operations, need to be undertaken to stabilise this structure. This included the. Supporting of the structure with a propping system, allowing for heavy plant to access the bridge to removed the existing surfacing, jacking the fallen stones back onto position, installing tie rods through the structure to ensure its integrity was maintained, parapet re-build works and resurfacing, including raising the carriageway levels at each side of the bridge to prevent due to vehicles bottoming out on the bridges camber.
