Project Name: Winterburn Bridge

Client: North Yorkshire County Council

Hinko were awarded this Grade II listed structure refurbishment in Dec 2017 as part of the NYCC Civil Engineering Framework.

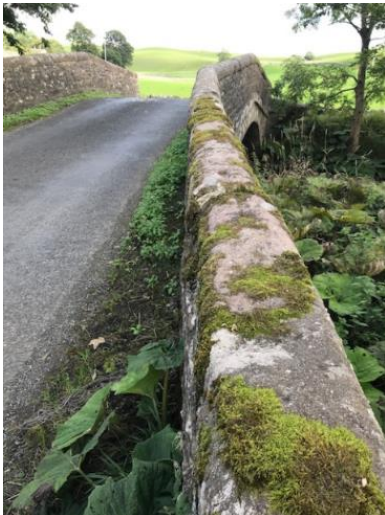
Winterburn Bridge was in a poor state of repair, the stone arch had started to spread causing several key stones to dislodge and drop down severely impeding the structure ability to support traffic flows above. The problem was

made worse by the steep camber over the bridge causing

vehicles to “bottom put” applying an impact load to the structure. In addition to this the parapet had been damaged and was bowing outwards and had been struck several times by passing vehicles.
