Project Name: Appersett Retaining Wall

Client: North Yorkshire County Council

Date: Jan 2017 to Feb 2017

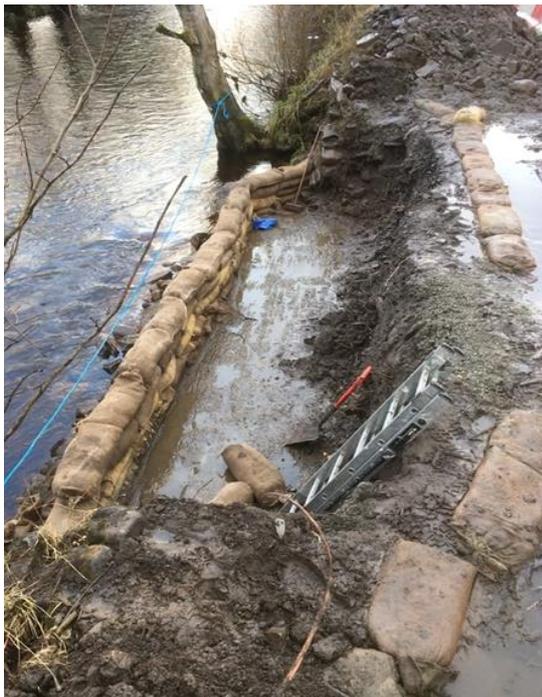
The River Ure had scoured the embankment adjacent to the A684 causing the road and verge to start to collapse.

To address the problem a new retaining wall was designed to support the collapsed area.

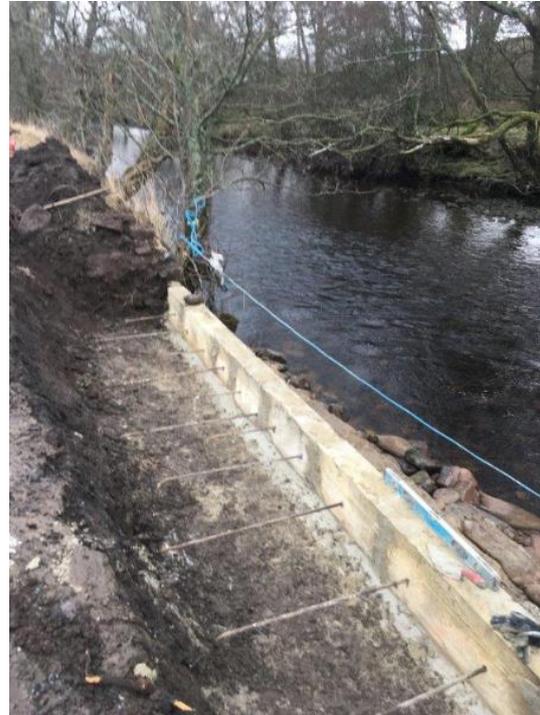
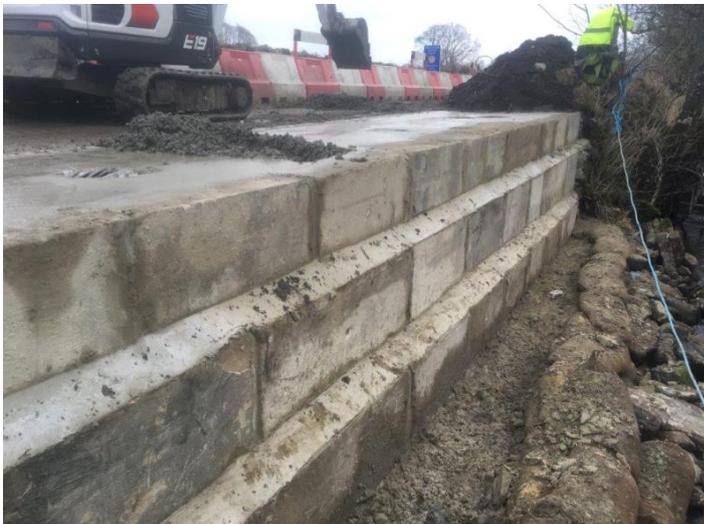
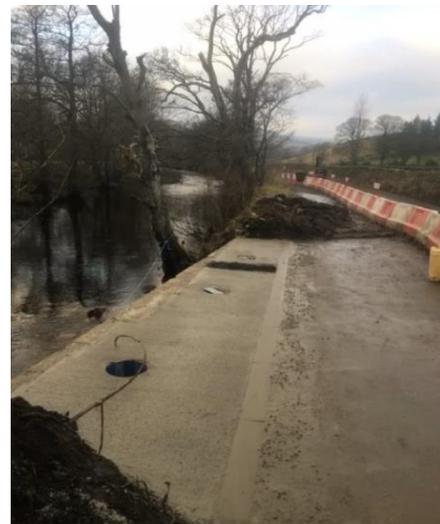
Once the base was constructed large blocks were lifted into position using a mini digger and kerb clamp.

Dowels were drilled and fixed into the rear of each block and the area mass filled with concrete to the rear.

The process was repeated until the wall was built to level.

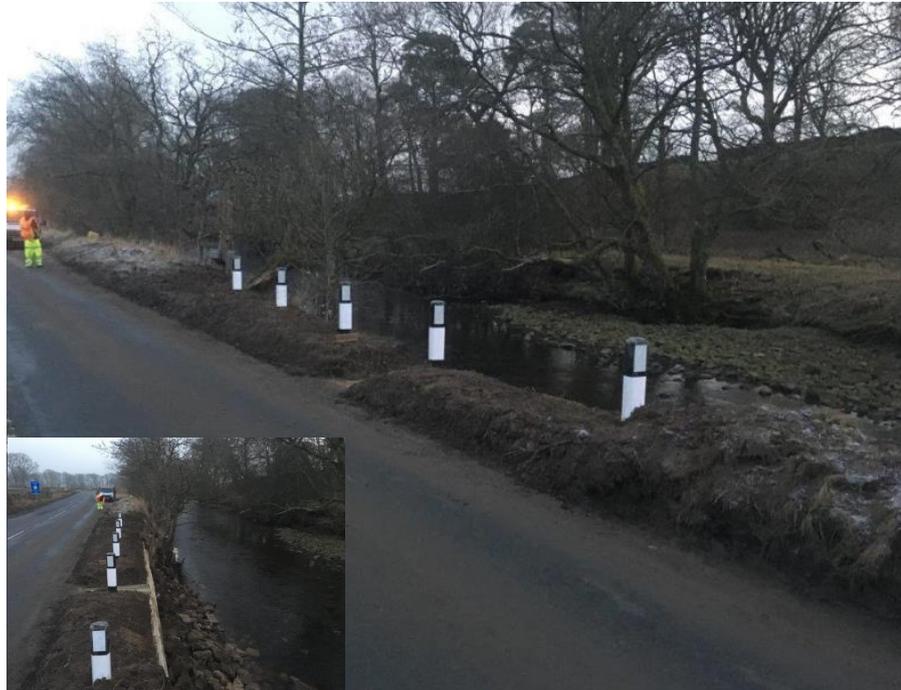
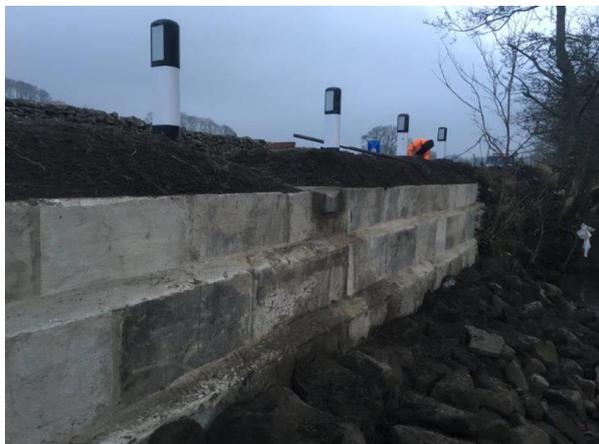
The verges were reinstated with top soil and seeded. This included the install of a drain to allow ponding water on the road to escape pas the verve and into the river also Hi Visibility bollards were installed along the work area to give motorists clear visibility.

Once the wall was built to level rip rap was placed in the river to the front of the wall to protect the foundations from further scouring and also offered habitat for ecology.
