Project Name: Church Fenton Bridge Collapse

Client: North Yorkshire County Council Highways Division

Date: Dec 2018

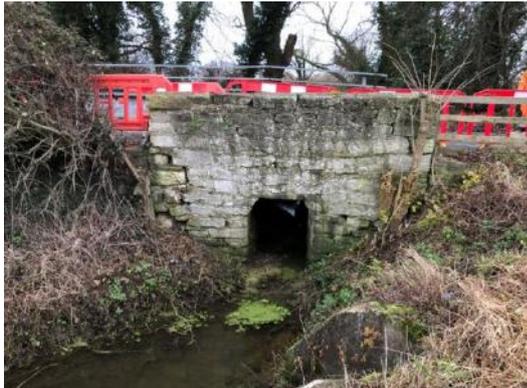
Early December 2019 the culvert crossing Main Street collapsed forcing the road to be closed.

Hinko were notified of the problem by the North Yorkshire County Council Engineering team and asked to install a temporary bridge to span the collapsed culvert.

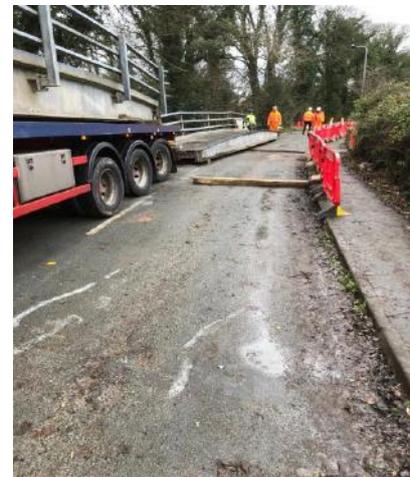
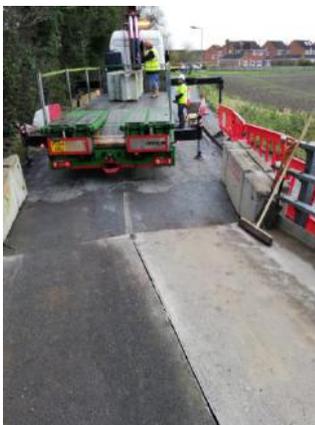
Within 24hrs of being requested to undertake the works Hinko had liaised with its supply chain to organise the delivery of a temporary bridge. The structure was lifted adjacent then skidded into position. Once in location the bridge was jacked up so it could be packed on hard wood sleepers which acted as abutments.

As the bridge comes in two halves pull lifts were used to secure the two halves of the bridge preventing movement.

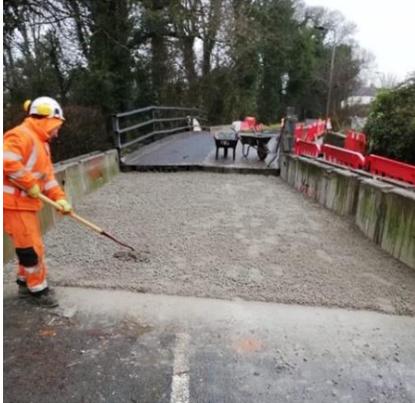
Once in position Concrete VTCB's were positioned at the four corners of the bridge on a splay to guide traffic in and also act as a retaining structure for ramps required either side of the bridge.

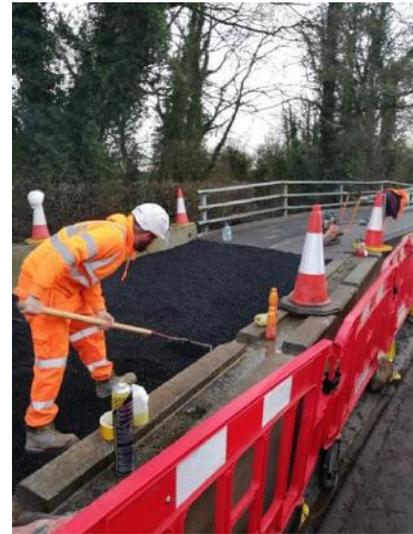
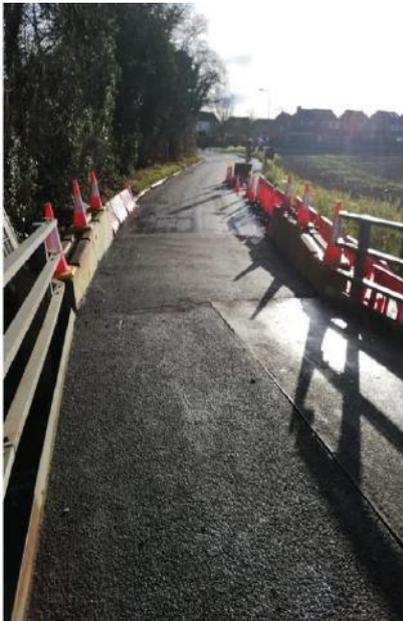
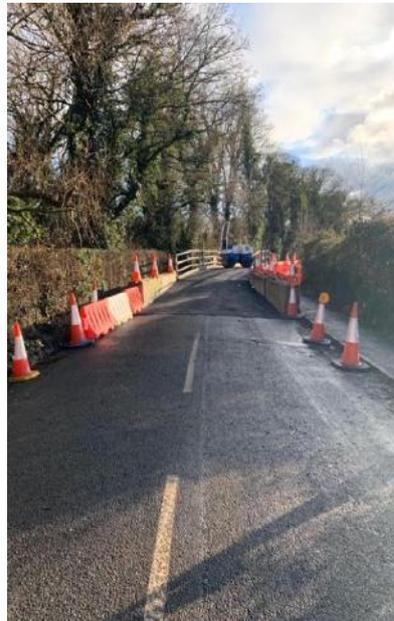
Once the TVCB's were positioned and utilising our in-house resource two No concrete ramps at a 1:12 gradient were constructed at each end of the bridge. This concrete was left 200mm down from Finished Road levels using our in-house resource

the concrete was allowed to cure overnight, the following morning Hinko operatives placed by hand a 200mm thick layer of Hard Stone Binder on top of the concrete to give a surface finish to the correct level allowing vehicles

access over the temporary bridge.

During the surfacing works Hinko's traffic management sub-contractor installed two way lights to control traffic over the bridge.

This also incorporated the install of temporary white lining, waterfilled barriers, reflective cones and lighting ensuring public safety as they used the bridge to get from one side of their village to the other.
