Project Name: Grinton South Bridge

Client: North Yorkshire County Council

Date: Aug 2019 – Sept 2019

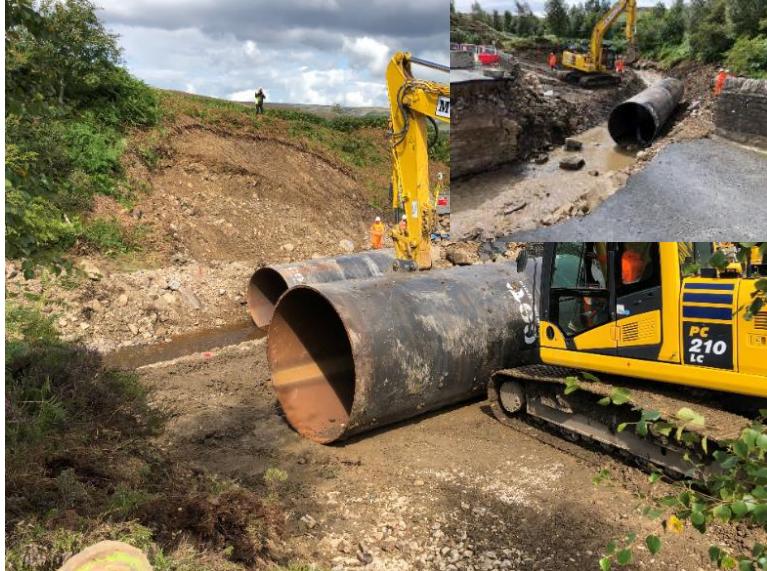
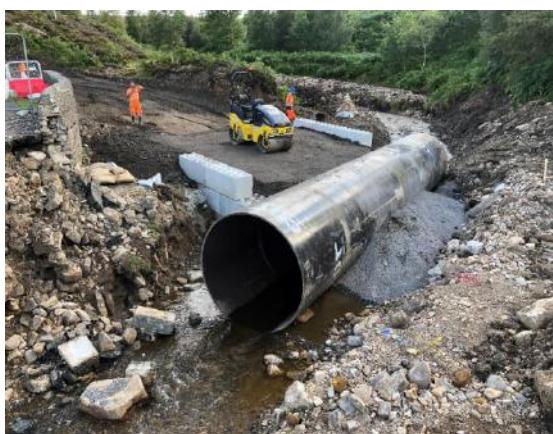
The works involved funnelling the watercourse through a temporary culvert then using reinforced earth construction techniques over the top to create the new road.

Hinko found that Pre-cast concrete culverts or pipes were not readily available, but the Hinko team quickly sourced large steel tubes from Cleveland Steel and Tubes, near Thirsk, had two disused parts of a Scottish wind turbine, which were cut to length, transported to the remote site and lowered into place so the road could be built over them.

Pre-Cast concrete 'lego' blocks were used to retain the fill materials at each side of the new bypass road, these were installed one level at a time trapping a layer of tensar reinforced geotextile between the upper and lower block to create the reinforced earth embankment.

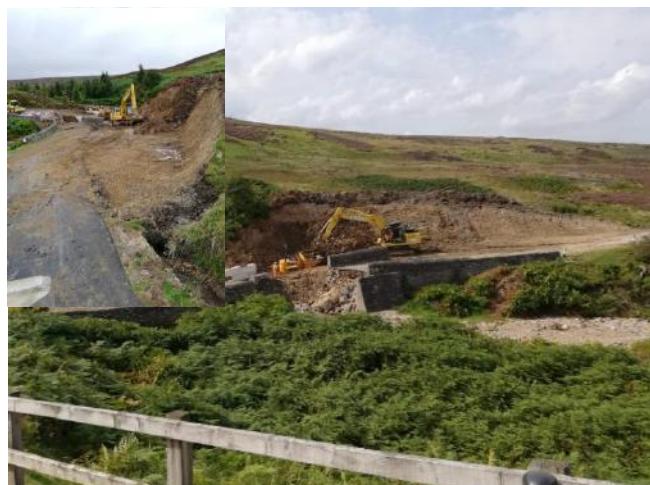
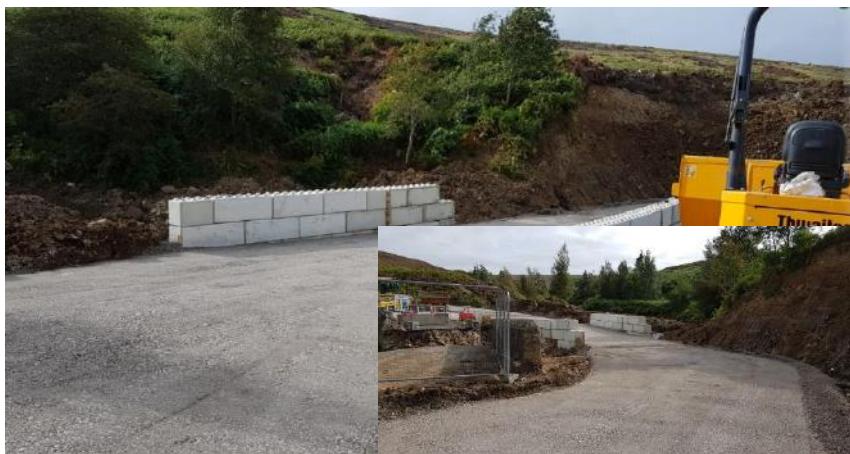
To get the desired road alignment and tie over 1500t of material had to be excavated and stored for reinstatement at a later date.

Due to the restricted access, Hinko used 6t Dumpers to move the material, the Hinko teams worked 7 days per week to ensure that the works would be finished within the 4-week period the site teams had agreed with North Yorkshire County Council.

The bypass road was constructed to formation level and compacted. Note using locally sourced, plant, and materials. Hinko have found by building local relationship's people genuinely take an interest in your works and will react quickly to your requests.

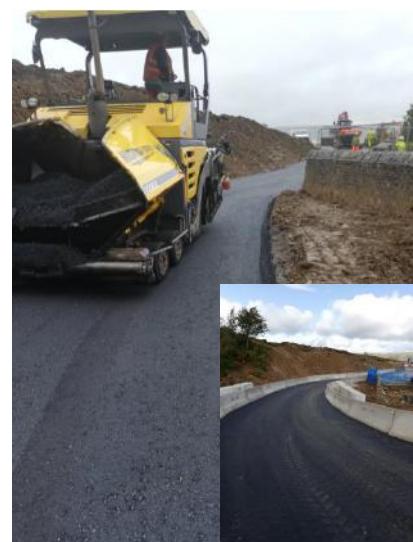
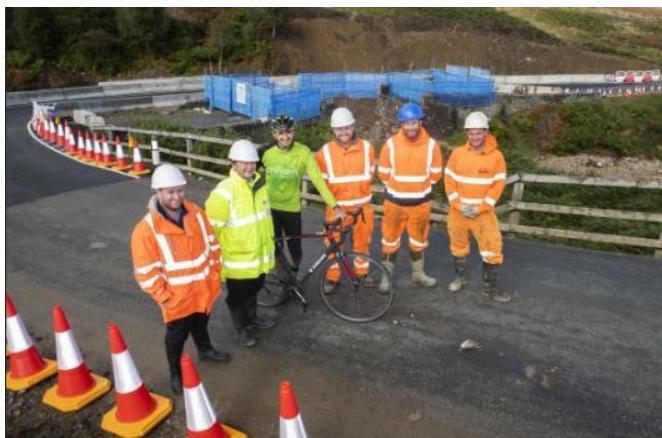
By spending time getting the sub-formation correct the surfacing works could be executed much quicker than originally anticipated full depth construction completed within two days. Allowing for white lining and TVCB install to be undertaken quickly and efficiently which lead to the early opening of the bypass.

The temporary crossing, opened on the 6th September 2019), some 4 weeks after the Hinko team mobilised to site.
