Project Name: Inghey River Aire Bridge

Client: North Yorkshire County Council

Hinko Construction Were Awarded this scheme based in Skipton in August 2018 by North Yorkshire County Council

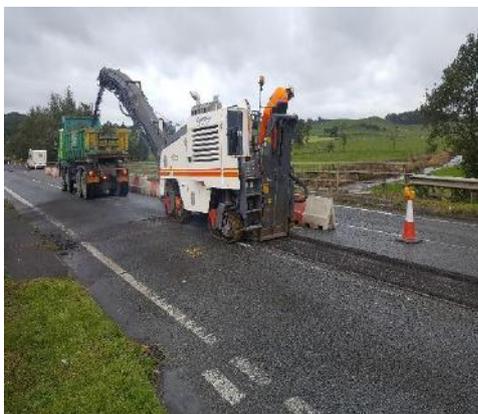
The initial works focused on traffic management establishment and cold milling of the existing surfacing to expose the bridge deck for preparation works for new waterproofing.

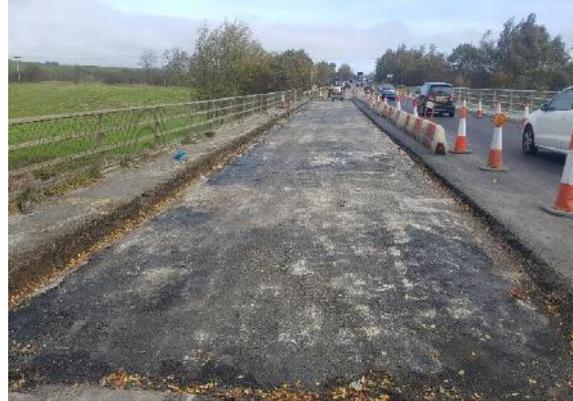
Several locations of damaged bridge deck were highlighted and associated repairs were made. Following on from this, known services were lifted from the Verge to allow full coverage of the waterproofing system.

Concrete repairs were required at the location of the existing joint, these became evident post removal, shuttering was installed and subsequent repairs were undertaken using rapid setting mortar, this allowed minimal delays to stage one of the waterproofing system application.

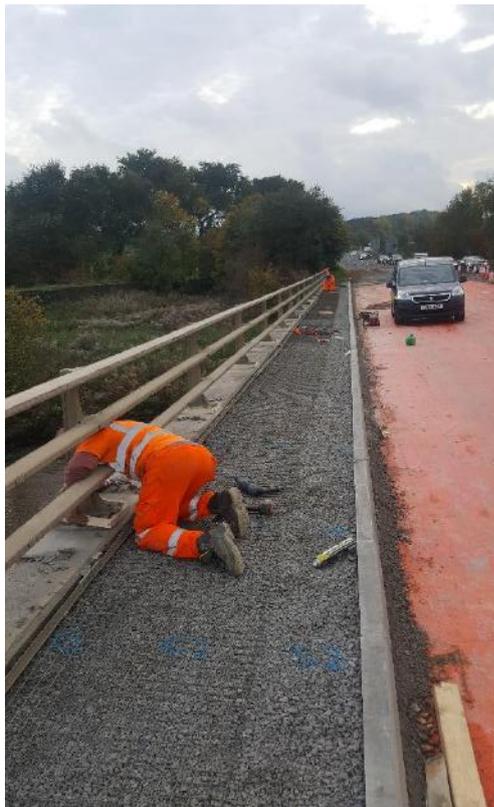
Waterproofing works commenced and all area of stage one was completed on programme. This allowed for installation of the new Kerb Line and No-Fines concrete verge infill.

Parapet mesh was removed and replaced prior to stage 1 surfacing works. This was to ensure minimal disruption to the surfacing operations. The contracted stated any defective areas of grout on the parapet posts should be removed and replaced. This was completed in a timely manner prior to the replacement mesh being fitted.

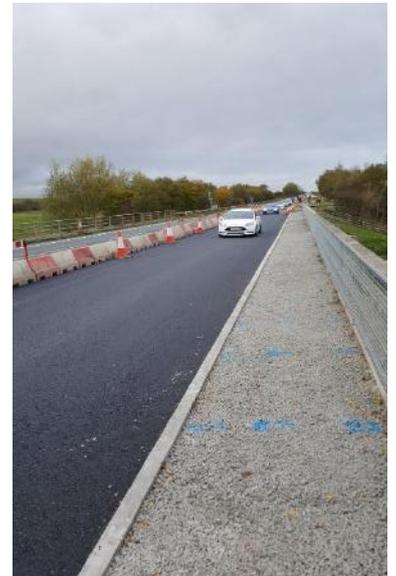
Surfacing was undertaken in 4 stages. Stage 1 was binder course on the South side of the scheme with well established ramps to transition traffic safely between new and existing levels. Upon completion of stage 1, traffic management was switched, opening the South Side of the scheme to the general public allowing the same processes to be undertaken on the North carriageway.

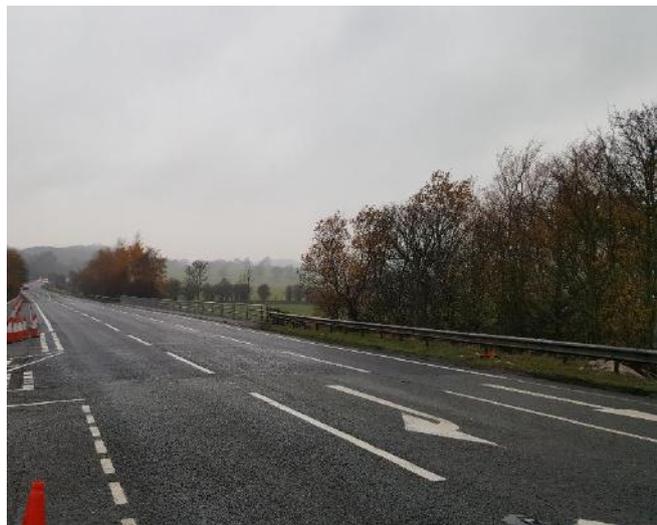
A single lane closure was left in place to allow road marking and stud work to be undertaken a side at a time.

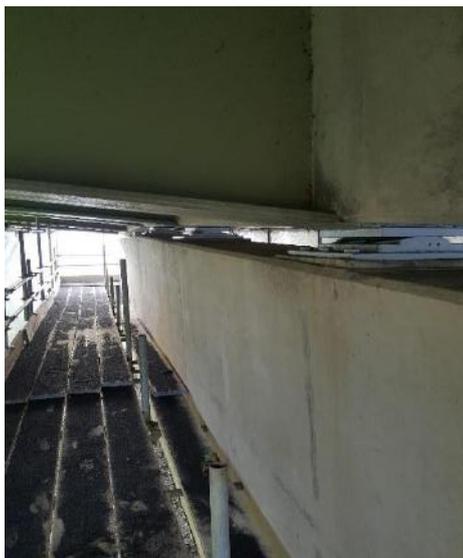
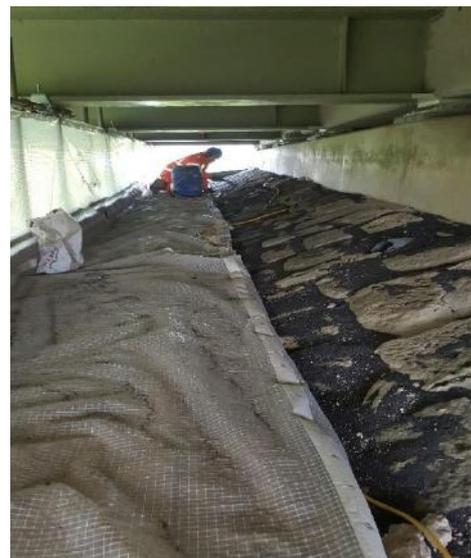
During the duration of works on the top of the deck, several areas of work were taking place underneath. This included establishment of encapsulated scaffold access to gain a safe working area to undertake open blasting of the bridge bearings to a S2.5 finish to allow them to be painted in a 3coat protective paint system.

All paintwork was removed from each bearing on both bearing shelves and a 3-coat paint system applied over the following 4days.

In addition, areas of defective concrete were highlighted on the bearing shelf which required to be removed and any defective areas of steel reinforcement removed and replaced with new. Each area was carefully broken out to an agreed point with the client and primed accordingly to be repaired.

When all concreting works had been completed, the access scaffold was removed and the entire area pressure washed to clean the bearing shelf of any debris.
