Project Name: Skip Bridge Refurbishment

Client: North Yorkshire County Council

Date: Jan 2018 – April 2018

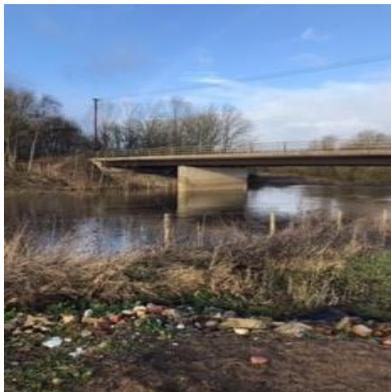
The structure has suffered from settlement and rotation at its abutments over the last 30 years to the point where the expansion gap at the structures free end was fully closed, thus the bridge was not moving as per its design.

The scheme included lifting the whole structure at its abutments 96mm on the West and 57mm on the East, bringing the alignment of the bridge back to its original profile.

The scheme also included bearing replacement at the abutments and concrete repairs to the abutment bearing shelves, piers and ballast walls, joint replacement and new VRS with HA compliant Parapet Transition.

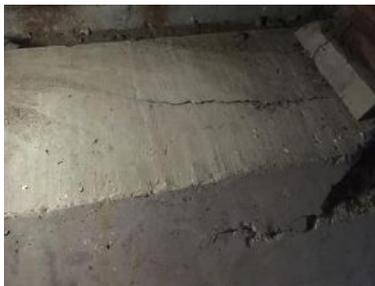
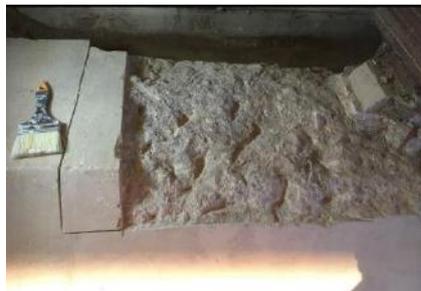
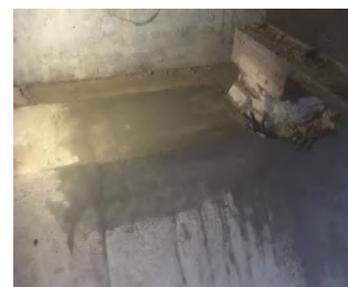
The first phase of the project was concrete repairs, this included breaking out defective concrete, there were substantial amount of repairs to undertake on the structure, care had to be taken to ensure that the works has no environmental or ecological impact.

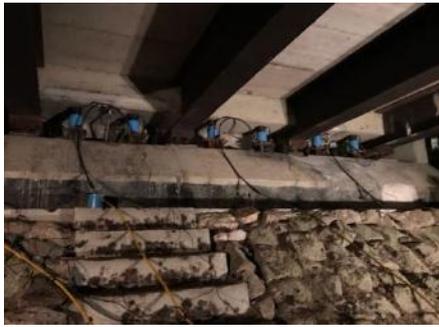
The structure was jacked to level on a night closure of the road, once to level temporary works packers were in place temporary ramps were installed to accommodate the new road level.

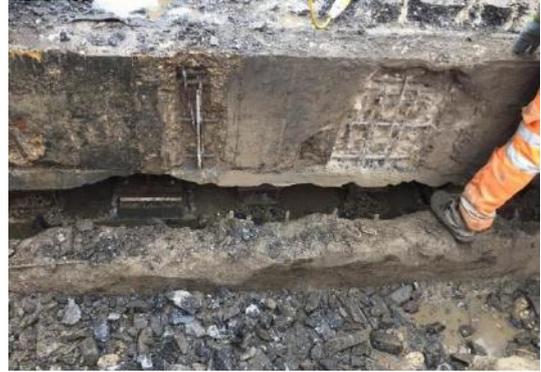
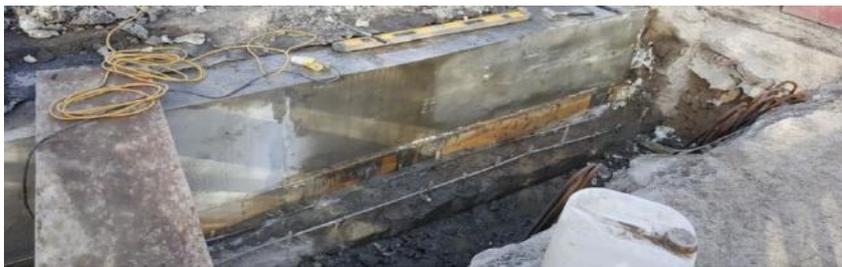
This allowed operatives to excavate down and expose the ballast walls which were in poor condition and required extensive remediation.

The Hinko team worked closely with the NYCC site representative to determine the best course of action to remediate the diaphragm wall.

The works involved removal of defective concrete and rebar and replacement as and where required.

High Strength Micro Concrete was used to remediate the diaphragm wall, giving durable solution to the defect.

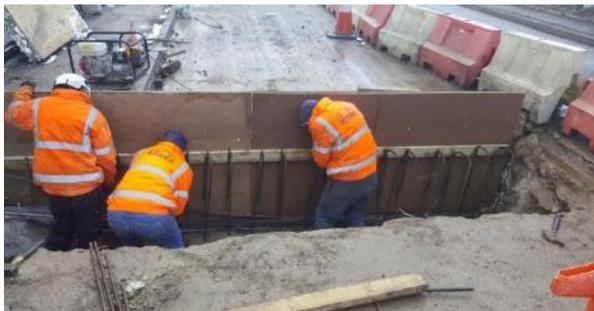
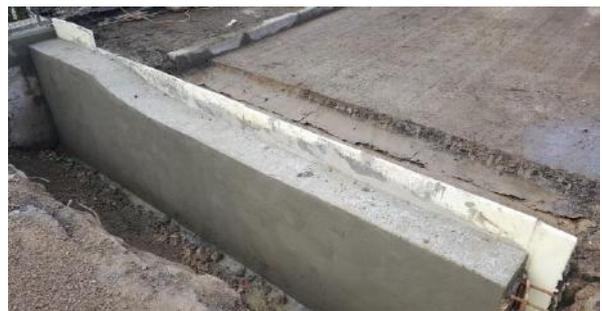
Once the diaphragm was complete the site team could then construct the new Ballast Wall, this was offset 30mm to allow for bridge movement.

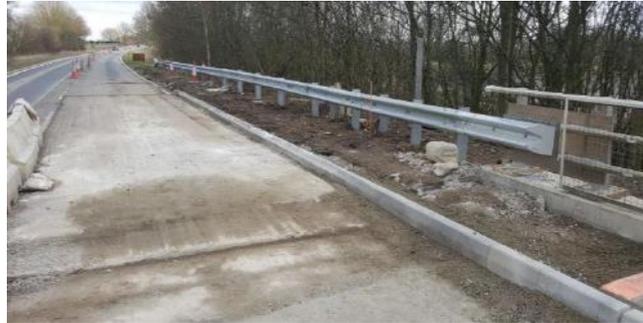
Concurrently the new VRS and Parapet transitions were installed at deck level. Once in place the works were repeated on the second half of the structure prior to resurfacing and joint works.
