Project Name: Thackley Retaining Wall

Client: Bradford Metropolitan District Council

As part of our framework contract with Bradford Council Hinko Construction Ltd were awarded this 6-week retaining wall remediation project.

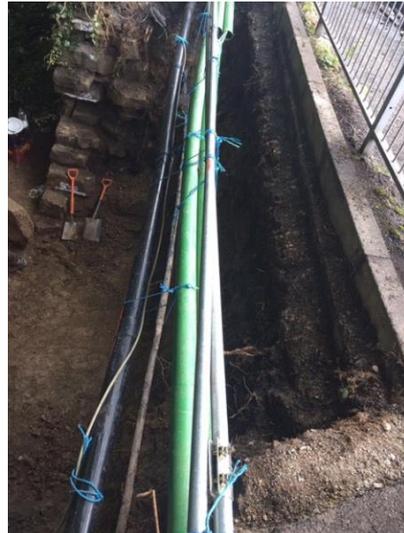
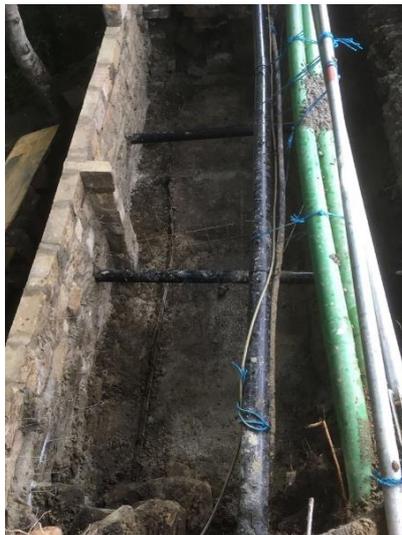
The existing retaining wall had collapsed due to a vehicle strike and posed significant risk to the highway and services in the footpath. Urgent re-build was required

The first thing the Hinko team did was deploy traffic management to remove traffic from within the angle of repose, removing loading for the collapsed wall area. In tandem the Hinko teams supported the existing services that including Virgin Media, BT and LV Electric.

It was found that the sub-formation was primarily mud stone allowing for an almost vertical face to be cut out of the embankments without fear of collapse.

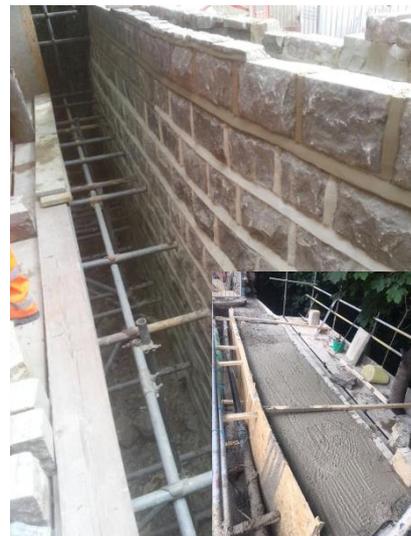
Once down to formation the Hinko site team cast a new Reinforced concrete base, off this base an exterior wall was constructed which would act as a shutter for a mass fill concrete infill, stabilising the area of collapse.

Once the wall was built to level the concrete infill wall undertaken to FRL, note this was undertaken in 500mm lifts to avoid damage to the perimeter wall which was being used as a shutter.

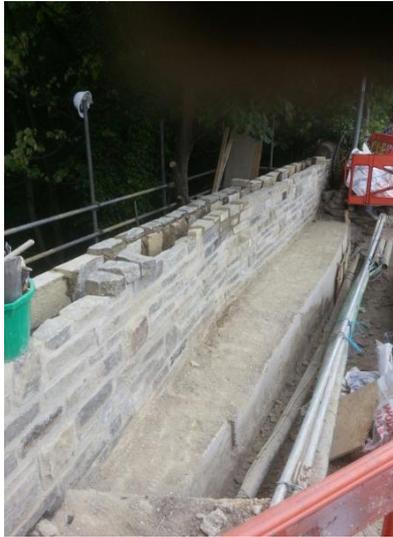
Once the concrete was fully installed then the new parapet wall could be re-built.

Utilising existing stone to ensure that the works were in keeping with the area the Hinko stone masons constructed a double skinned wall, with concrete infill to ensure additional stability and strength.

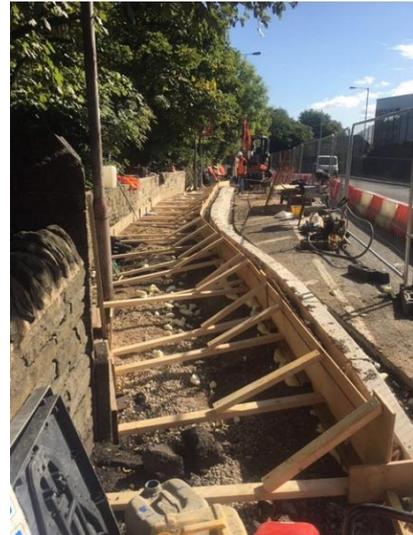
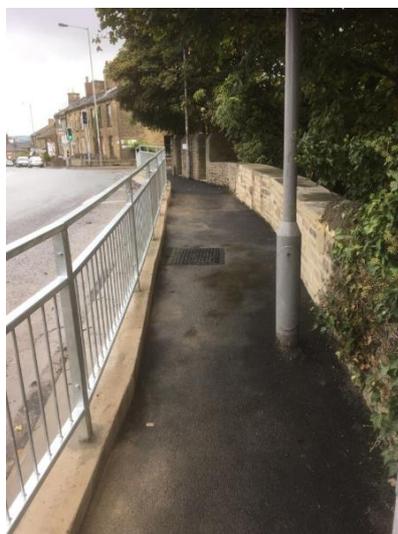
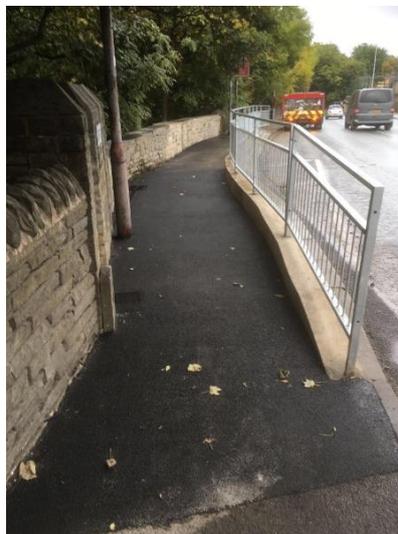
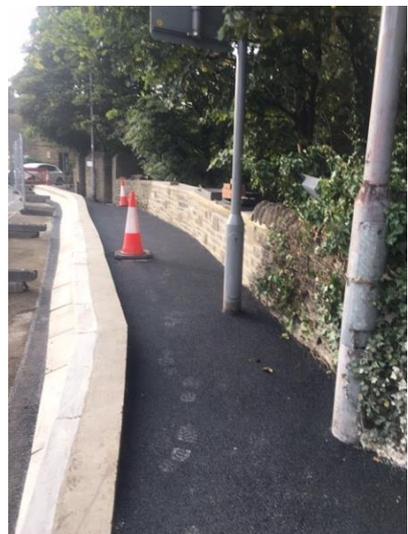
To do this a Treif Kerb Solution was devised providing a vehicle restraint statement that require little or no maintenance could be tied into the existing kerb system.

As the Trief kerbs would sit up above footpath level a

ground beam was cast to the rear of the kerbs allowing for the setting in of a pedestrian handrail. This eliminated the potential trip hazard caused by the upstand on the kerbs.

Once completed the new footpath was surfaced utilising in house resource and pedestrian fencing grouted into place along the ground beam.
