**Project Name:** Grinton South Bridge

**Client:** North Yorkshire County Council

**Date:** Aug 2019 – Sept 2019

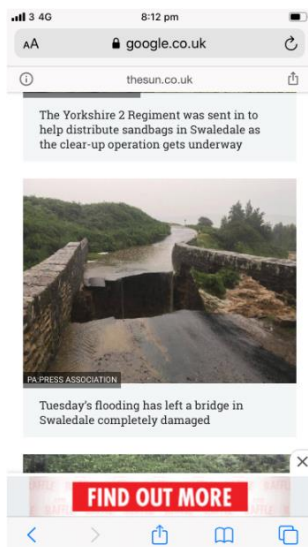
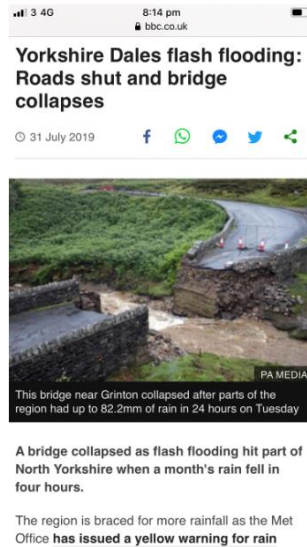
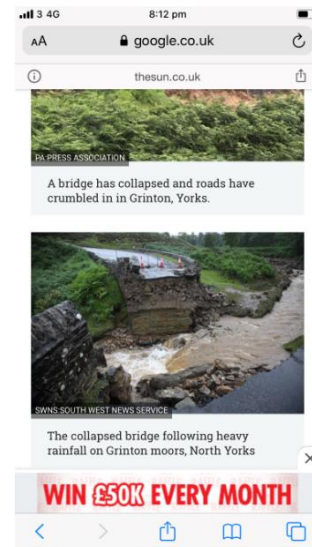
In July 2019 the town of Grinton (North Yorkshire) and surrounding areas suffered severe flooding due to a 1:1000 year flood event. Such was the force of the water that it caused Grinton South Bridge to collapse. The event received coverage from national tabloids and the BBC.

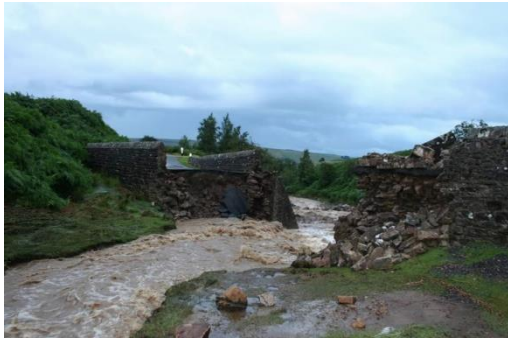
The event occurred on Tuesday the 30<sup>th</sup> July 2019 the damage was assessed by NYCC engineers on Wednesday 31<sup>st</sup> July 2019 and on Friday 2<sup>nd</sup> August 2019 Hinko were appointed under emergency powers to address the problem.

Hinko mobilised to site on Monday the 5<sup>th</sup> Aug 2019 and commenced with the remediation.

The primary aim was to build a bypass road around the collapsed bridge, which had a twofold benefit. Engineering principals and norms could be used to quickly design the bypass road and the install of a new bypass would allow the collapsed bridge to be re-built at a later date without impacting local traffic.

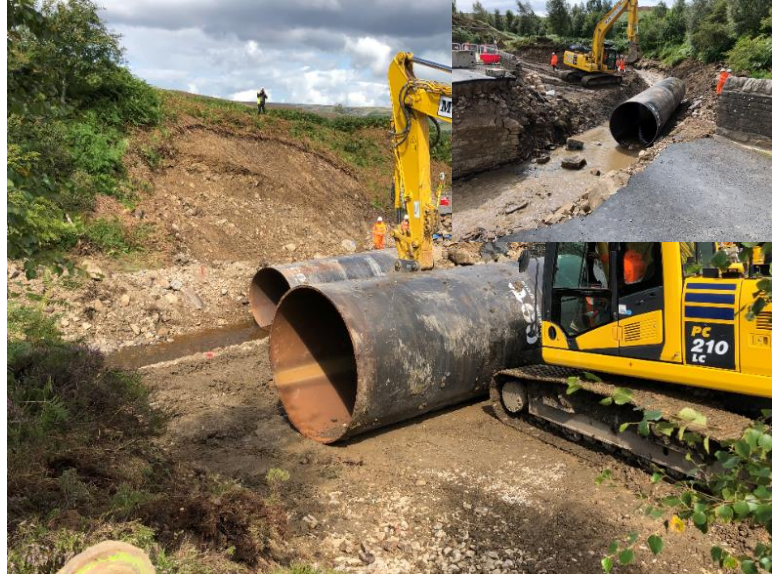
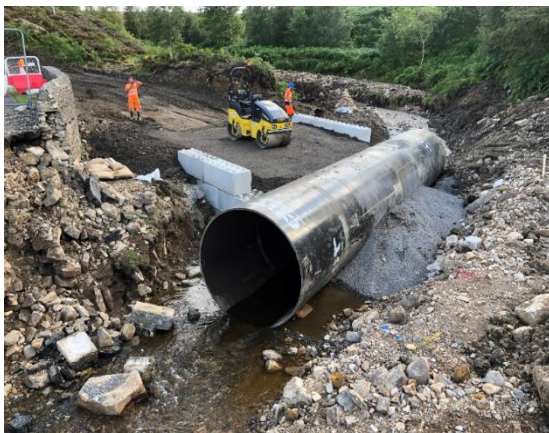
The works involved funnelling the watercourse through a temporary culvert then using reinforced earth construction techniques over the top to create the new road.

Hinko found that Pre-cast concrete culverts or pipes were not readily available, but the Hinko team quickly sourced large steel tubes from Cleveland Steel and Tubes, near Thirsk, had two disused parts of a Scottish wind turbine, which were cut to length, transported to the remote site and lowered into place so the road could be built over them.

Pre-Cast concrete 'lego' blocks were used to retain the fill materials at each side of the new bypass road, these were installed one level at a

time trapping a later of tensar reinforced geotextile between the upper and lower block to create the reinforced earth embankment.

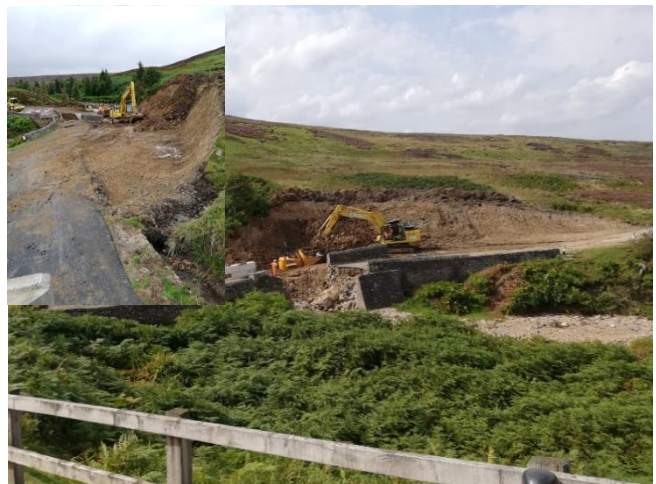
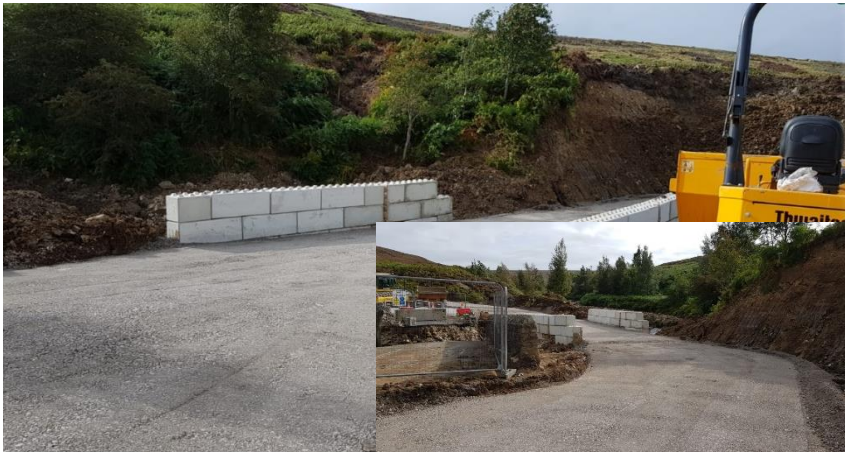
To get the desired road alignment and tie over 1500t of material had to be excavated and stored for reinstatement at a later date.

Due to the restricted access, Hinko used 6t Dumpers to move the material, the Hinko teams worked 7 days per week to ensure that the works would be finished within the 4-week period the site teams had agreed with North Yorkshire County Council.

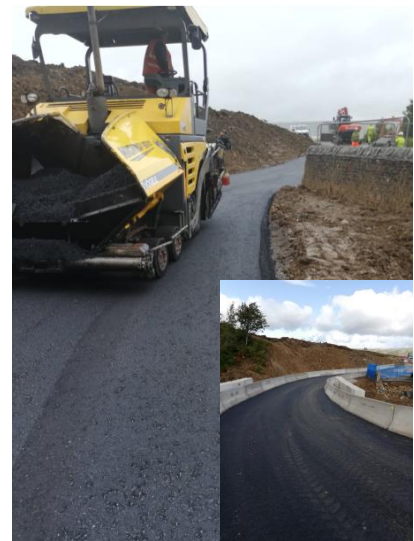
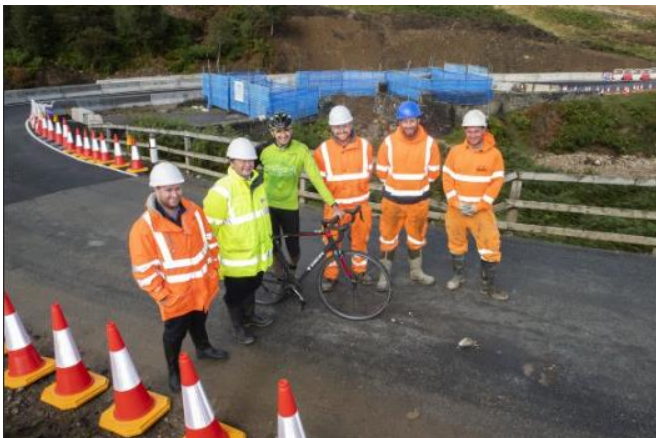
The bypass road was constructed to formation level and compacted. Note using locally sourced, plant, and materials. Hinko have found by building local relationship's people genuinely take an interest in your works and will react quickly to your requests.

By spending time getting the sub-formation correct the surfacing works could be executed much quicker than originally anticipated full depth construction completed within two days. Allowing for white lining and TVCB install to be undertaken quickly and efficiently which lead to the early opening of the bypass.

The temporary crossing, opened on the 6<sup>th</sup> September 2019), some 4 weeks after the Hinko team mobilised to site.
