Project Name: Horton Park School Retaining Wall

Client: Bradford Metropolitan District Council

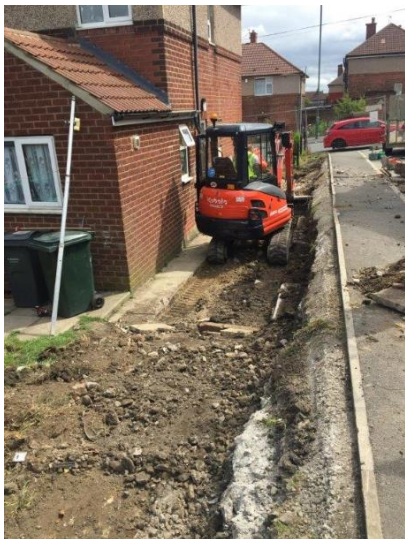
The existing access to Horton Park School had seen degrees of movement and also offered no edge protection to the users of the footpath.

To address this Bradford Metropolitan District Council designed a mass fill concrete retaining wall clad with Brickwork.

This would not only stabilise the road but also act as edge protection to the walkway.

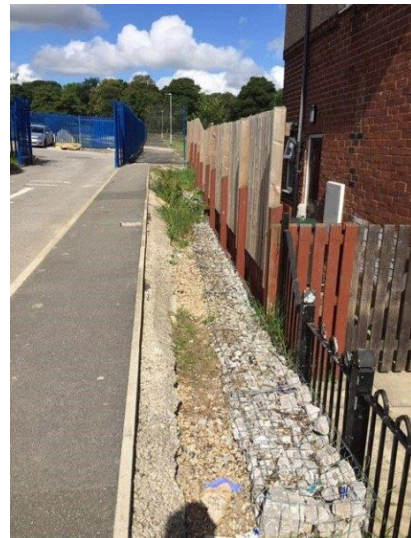
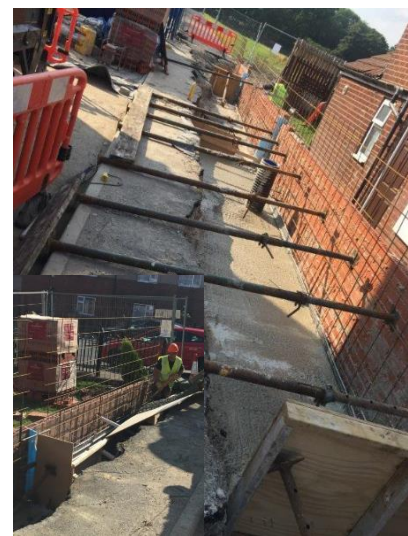
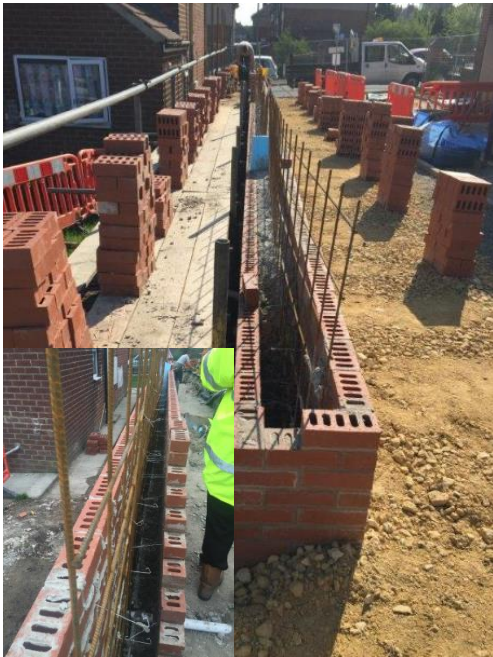
Once to formation the resultant foundation was cast allowing for brickwork to be built. Mass concrete infill was cast to the rear of the wall. The Hinko site team used Acro Props to support the brickwork during this pouring operation. The mass concrete was taken up in 300mm lifts to ensure that too much pressure was not applied to the brickwork.

Once to footpath level the internal wall was built, this incorporated a cavity into the wall, which was later mass filled with concrete giving stability and strength to the wall.

As the wall was constructed scaffolding was used to one side for access and backfill to the opposite side, removing the requirement for any access.

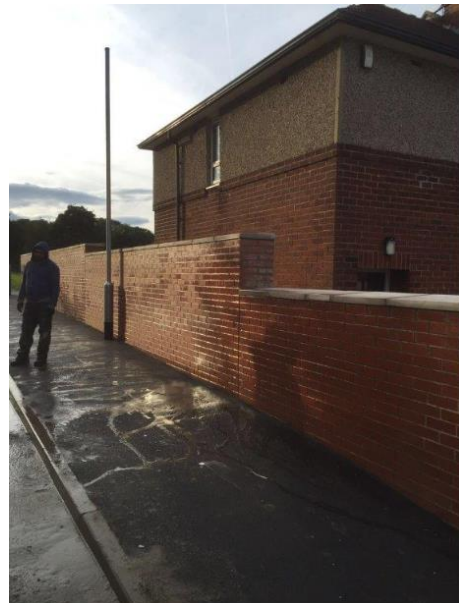
Once the wall was to level new coping stones were bedded on the top of the wall capping it off.

Dowels were used to drill through and embed the copings to the top of the concrete infill wall, to reduce the chance of vandalism and damage to the wall's copers.

the brickwork was coated in anti-graffiti paint to allow ease of cleaning if the wall was vandalised.

Once complete the site was cleared and the footpath re-surfaced giving a high quality finished product.
