Project Name: Winterburn Bridge

Client: North Yorkshire County Council

Date: October 2018 – Nov 2018

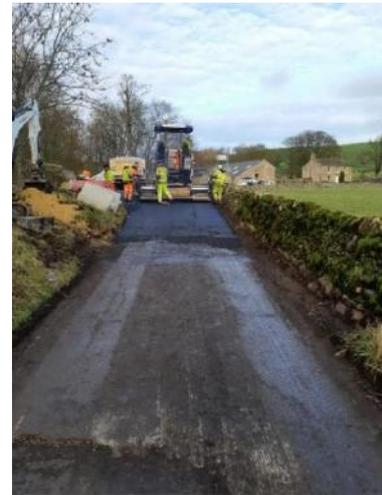
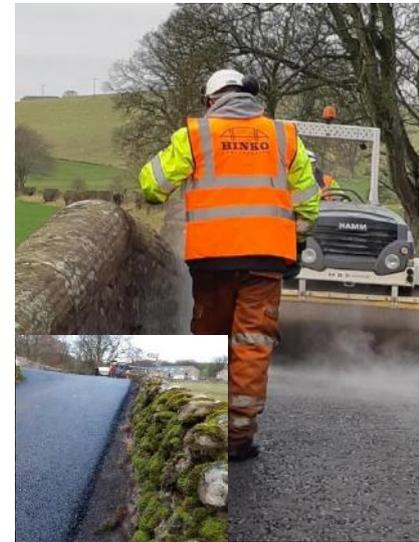
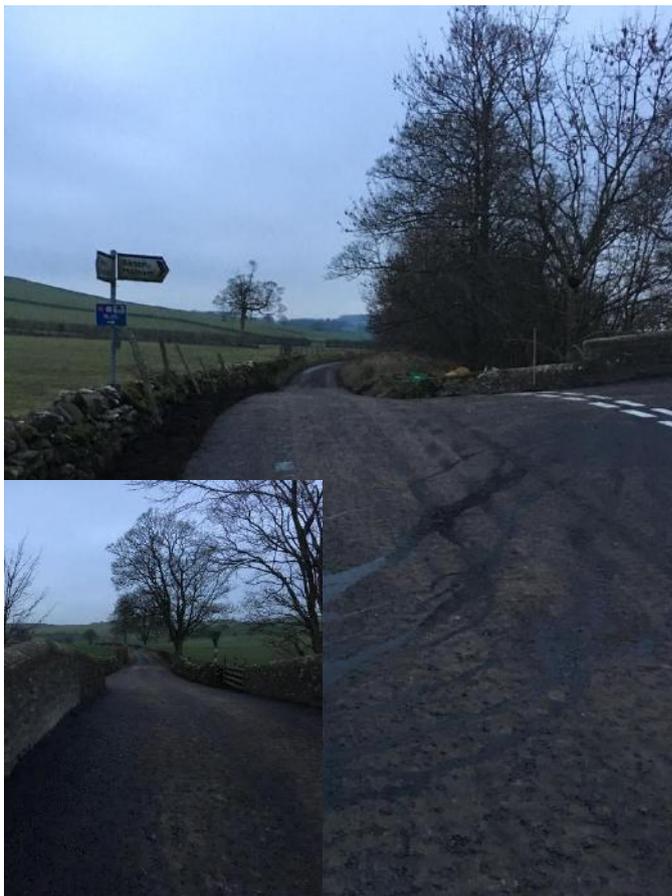
The works had to be undertaken under a full road closure due to the width of the road and 3 x Tie-ins cold milled to accept 100mm AC 32 HDM 40/60 Base Course, 50mm of AC 20 HDM 40/60 and 50mm of HRA 30/14 PMB WTR2 and 60 PSV Pre Coated Chippings. Tanker applied bond coat were used for each layer before surfacing commenced.

The project was executed in line with budget, programme and safety and quality standards.

By utilising the in-house surfacing resource Hinko was able to deliver the works to a quality standard beyond our client's expectations.
