Project Name: Winterburn Bridge

Client: North Yorkshire County Council

Hinko were awarded this Grade II listed structure refurbishment in Dec 2017 as part of the NYCC Civil Engineering Framework.

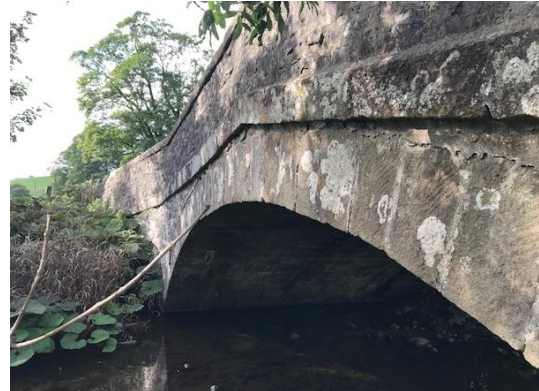
Winterburn Bridge was in a poor state of repair, the stone arch had started to spread causing several key stones to dislodge and drop down severely impeding the structure ability to support traffic flows above. The problem was

made worse by the steep camber over the bridge causing

vehicles to “bottom put” applying an impact load to the structure. In addition to this the parapet had been damaged and was bowing outwards and had been struck several times by passing vehicles.

To address the problem several operations, need to be undertaken to stabilise this structure. This included the. Supporting of the structure with a propping system, allowing for heavy plant to access the

bridge to removed the existing surfacing, jacking the fallen stones back onto position, installing tie rods through the structure to ensure its integrity was maintained, parapet re-build works and resurfacing, including raising the carriageway levels at each side of the bridge to prevent due to vehicles bottoming out on the bridges camber.
