**Project Name:** Horton Park School Retaining Wall

**Client:** Bradford Metropolitan District Council

**Date:** July 2016 to Sept 2016

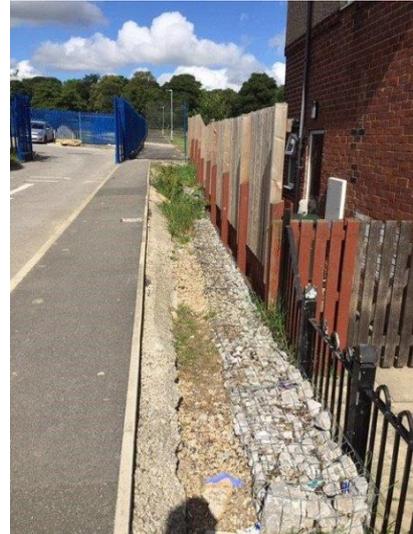
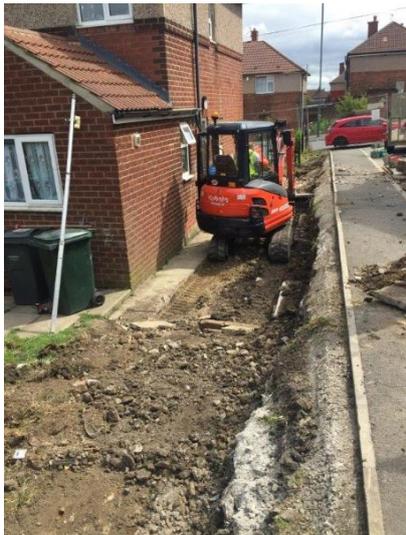
The first operation was to excavate to formation, close liaison with residents was essential, however by explaining what the work involved and the benefits, this combined with undertaking the works during the school summer holidays we were able to undertake the works without disrupting peoples every day activities.

Using a 3t mini digger the foundations of the wall were excavated, the ground was stable which meant that no temporary works was required to support the excavation.

Once to formation the resultant foundation was cast allowing for brickwork to be built. Mass concrete infill was cast to the rear of the wall. The Hinko site team used Acro Props to support the brickwork during this pouring operation. The mass concrete was taken up in 300mm lifts to ensure that too much pressure was not applied to the brickwork.

Once to footpath level the internal wall was built, this incorporated a cavity into the wall, which was later mass filled with concrete giving stability and strength to the wall.

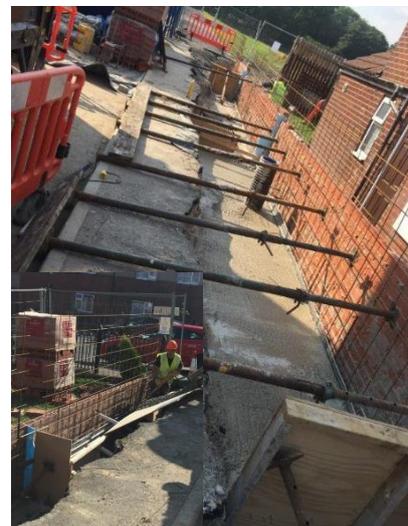
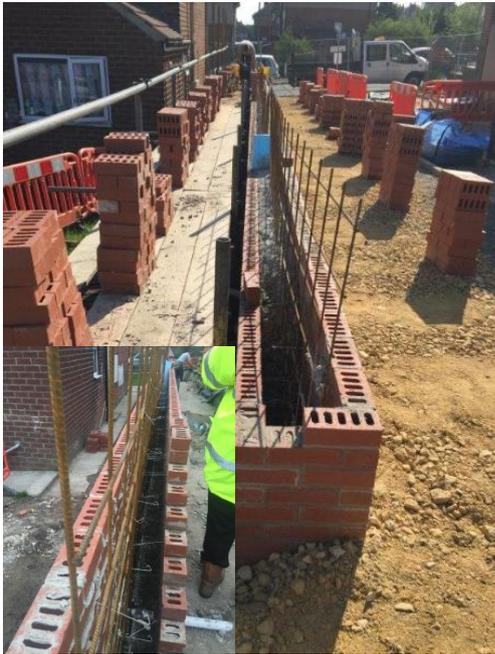
As the wall was constructed scaffolding was used to one side for access and backfill to the opposite side, removing the requirement for any access.

Once the wall was to level new coping stones were bedded on the top of the wall capping it off.

Dowels were used to drill through and embed the copings to the top of the concrete infill wall, to reduce the chance of vandalism and damage to the wall's copers.

the brickwork was coated in anti-graffiti paint to allow ease of cleaning if the wall was vandalised.

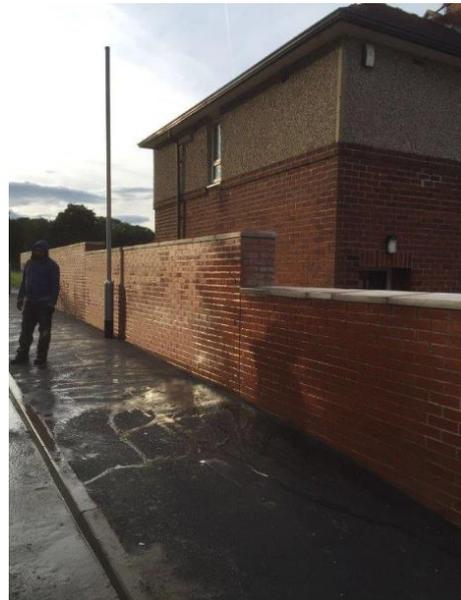
Once complete the site was cleared and the footpath re-surfaced giving a high quality finished product.

The footpath was re-opened ready for the beginning of the school year.
